The Friends of St Breaca Church

NEWSLETTER

April 2017

The Roof Repair Project

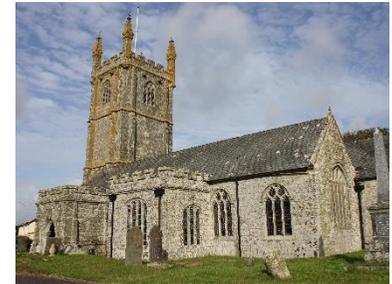
A mini digger was used to excavate the drainage channels. A perforated pipe system was installed.

The project took over a year to complete and began with the removal of the existing clay drainage channels around the church. A mini digger was brought in to excavate a deeper channel around the base of the building and a new system using perforated pipes laid on a membrane and topped with granite chippings has been installed in its place. It is hoped this will more effectively discharge rainwater and surface water and take it away from the base of the church. The interior level of the church is considerably below that of the exterior. This new system should ensure that the inside of the building remains less damp than it was originally.

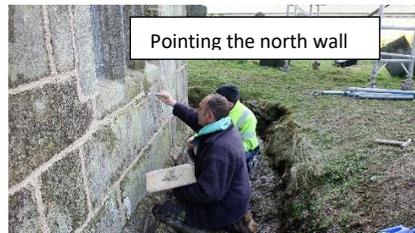
All inappropriate cementitious mortar needed to be removed and the joints raked out in preparation for the lime pointing. Cement does not allow a stone building to breathe whereas lime mortar enables any moisture to evaporate naturally.

At the same time the exterior wall in the north aisle was repointed using lime mortar. This lay outside the scope of the roof project, so the cost of this was supported by just over £1,500 from the Friends and a grant of £2,500 from the Allchurches Trust. It was a good opportunity to have this work undertaken whilst the contractors were on site. The area is where the most significant of the church's wall paintings are situated and the work needed to be done before planned restoration work to the paintings was due to start later in the Spring of 2017.

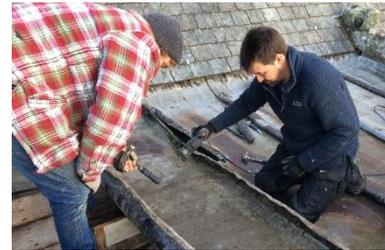
Removing the existing lead sheet proved difficult as it was very thick. It had to be cut into manageable pieces so that it could be removed.

The final stage of the roof project was completed at the beginning of March 2017 with the replacement of the flat lead roof to the porch in the South Transept. The original lead sheeting dates back to 1770 and was the thickest lead that the roofing contractors had ever seen. There was some delay in finding a suitable contractor to carry out the work as it is very specialised. The work has been carried out to a very high standard and should hopefully ensure that this particular roof will last for a considerable time.

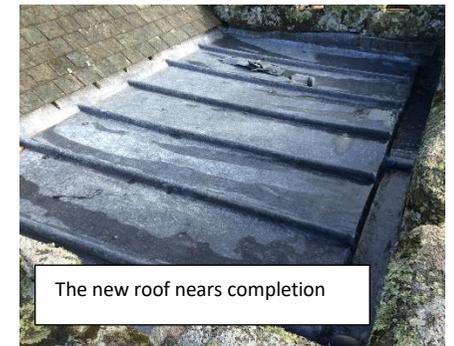
The new lead sheet is being laid in sections. Each section has to be shaped carefully despite its thickness
